## JENKINS LOG FARM HOUSE

AL-VI-B-030

.3 mile south of Cabin Run Road

# Maryland Historical Trust State Historic Sites Inventory Form

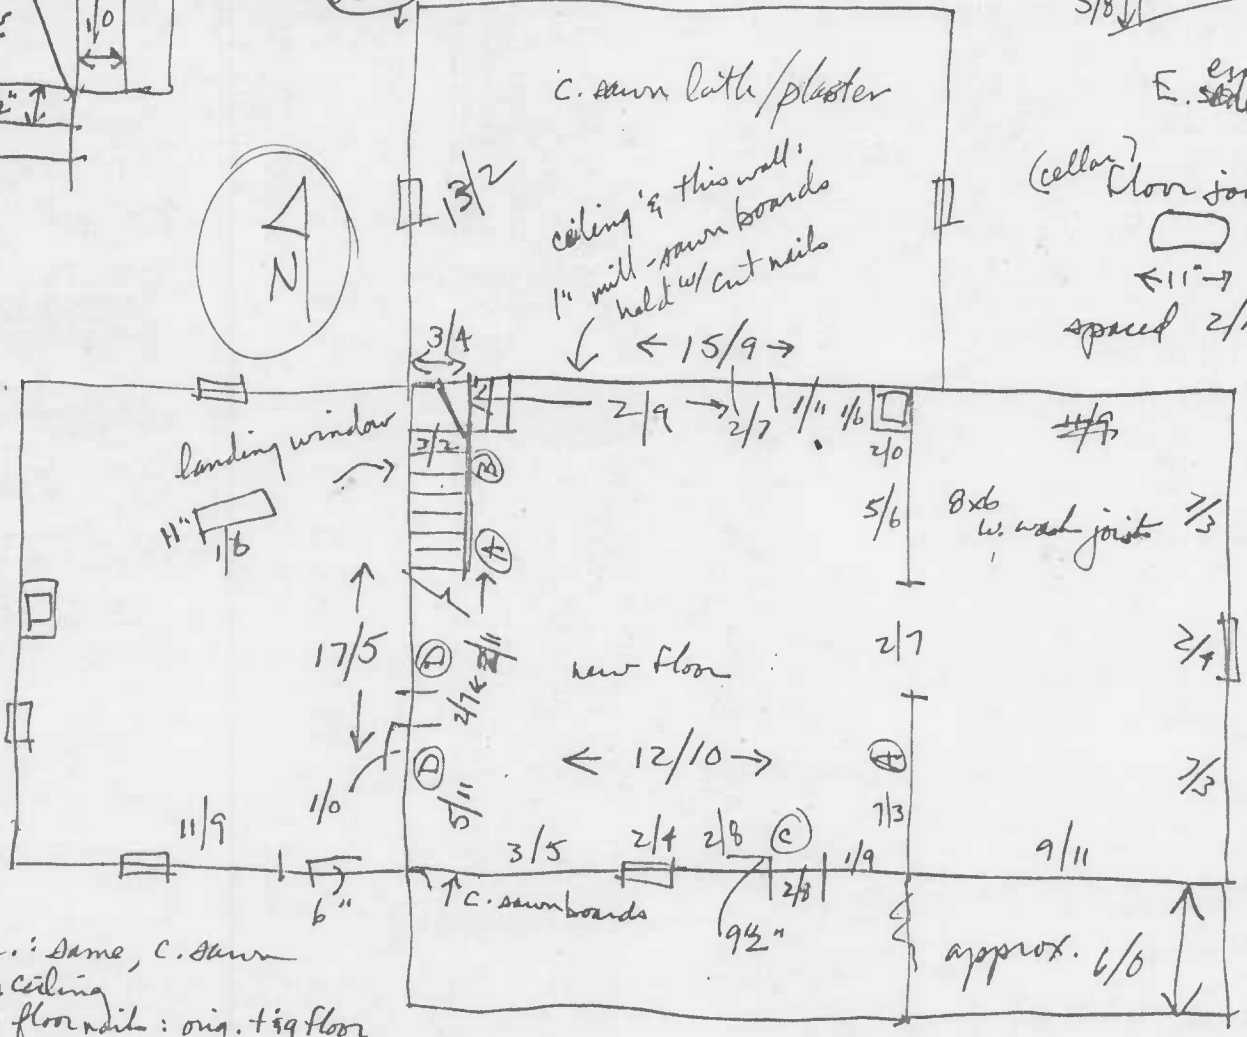
AL-III-B-030 "Log Farm House"  
Merry Stinson 9/14/82

(cellar) floor joists

← 11" →  
spaced 2/10 on center

straight mill-sawn  
(oak or chestnut)

C. sawn lath/plaster

ceiling & this wall:  
1" mill-sawn boards  
held w/ cut nails  
← 15/9 →

2nd fl.: same, C. sawn  
part. & ceiling  
T. head floor nails: orig. + ig floor

wood billet chinking  
mud daub  
w. wash  
blue paint (later lath & plaster)  
red trim

ⓓ logs removed c. 4 1/2' high:  
former fireplace location?

ⓐ head + ig bd. part.

ⓑ stair rebuilt using orig. + ig head bd. part. (oak or chestnut)

stair closet: 2-part chain rail re-used as stair support  
risers nailed into heads (visible in closet) w/

ⓐ not orig. door frame: wire nails

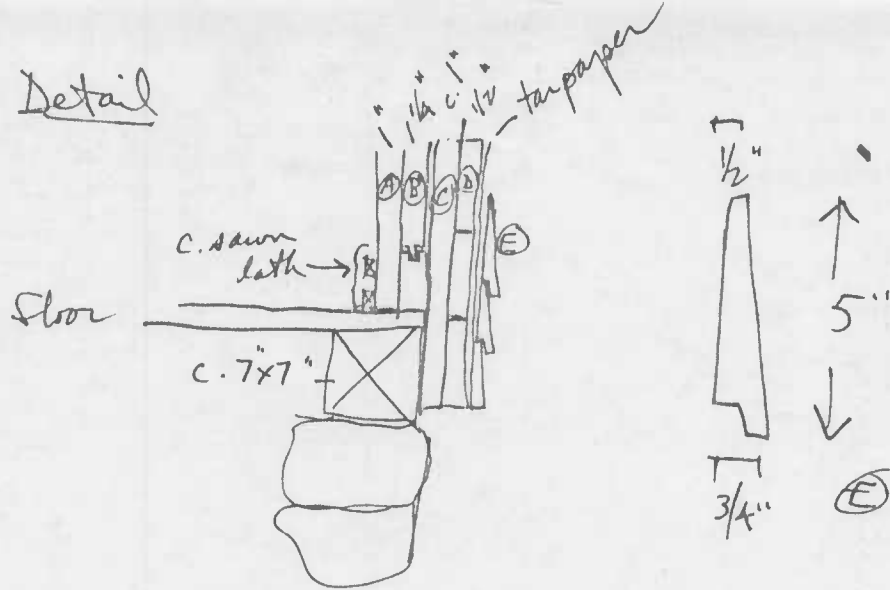
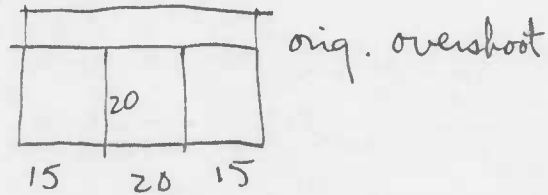
# Detail

Ⓐ triple-stud at corner

all wire nail

- Ⓐ x 1 3/4" stud
- Ⓑ horizontal boards 7"-9"
- Ⓒ vertical "board/studs" at intervals 1"x4" c. 10" apart
- Ⓓ thin boards 7"-9"

The house is significant for its early log construction as well as for the construction of the north addition. This structure's wall utilizes five layers of small studs and horizontal and vertical planks sandwiched together. This construction seems to be either transitional between stud-frame and plank construction, or a deliberate cross of the two types.

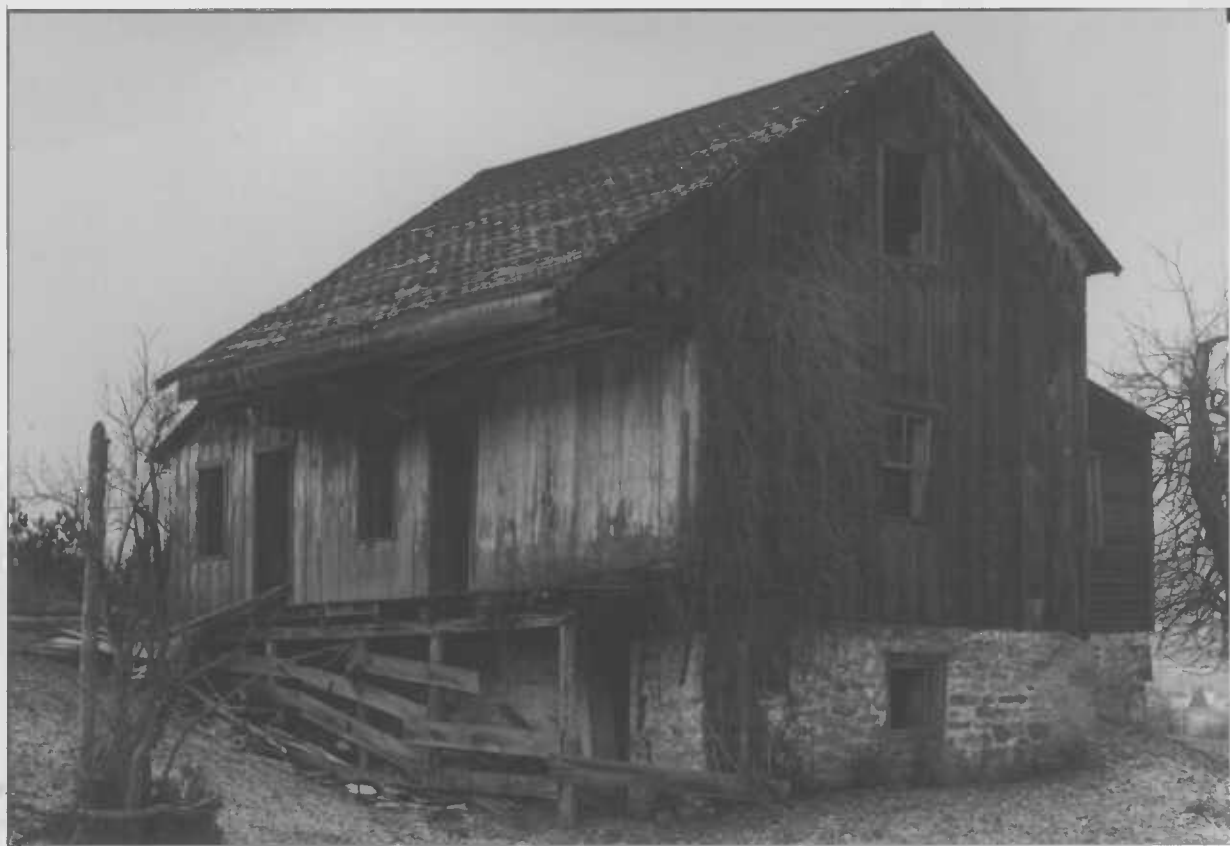
Log Farm House

Northwest

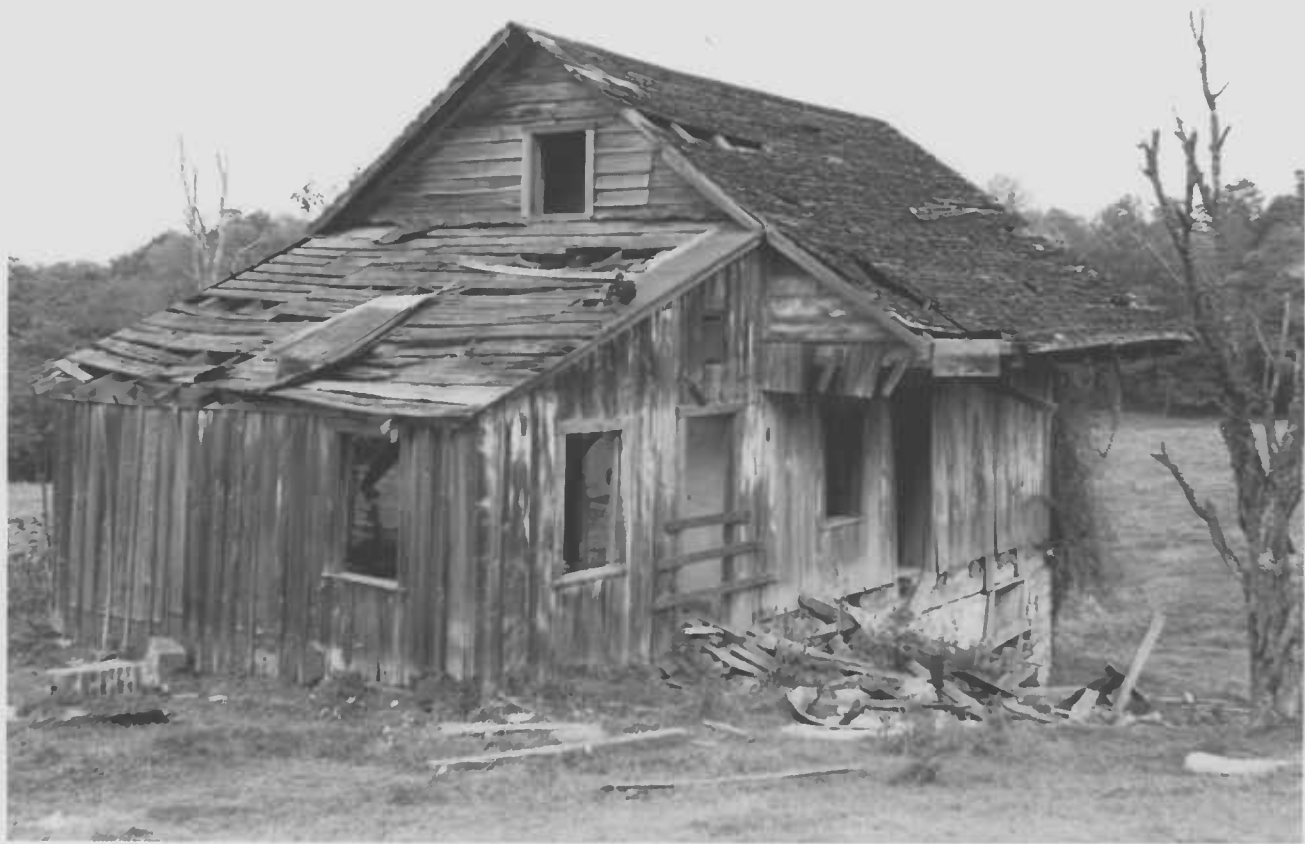
Log Farmhouse

Facade N.W. elev.

The two-bay farmhouse faces south. The stone cellar is exposed on this side. A pent roof extending from the main gable roof covers the facade. Late 19th century frame additions cover the west and north sides.

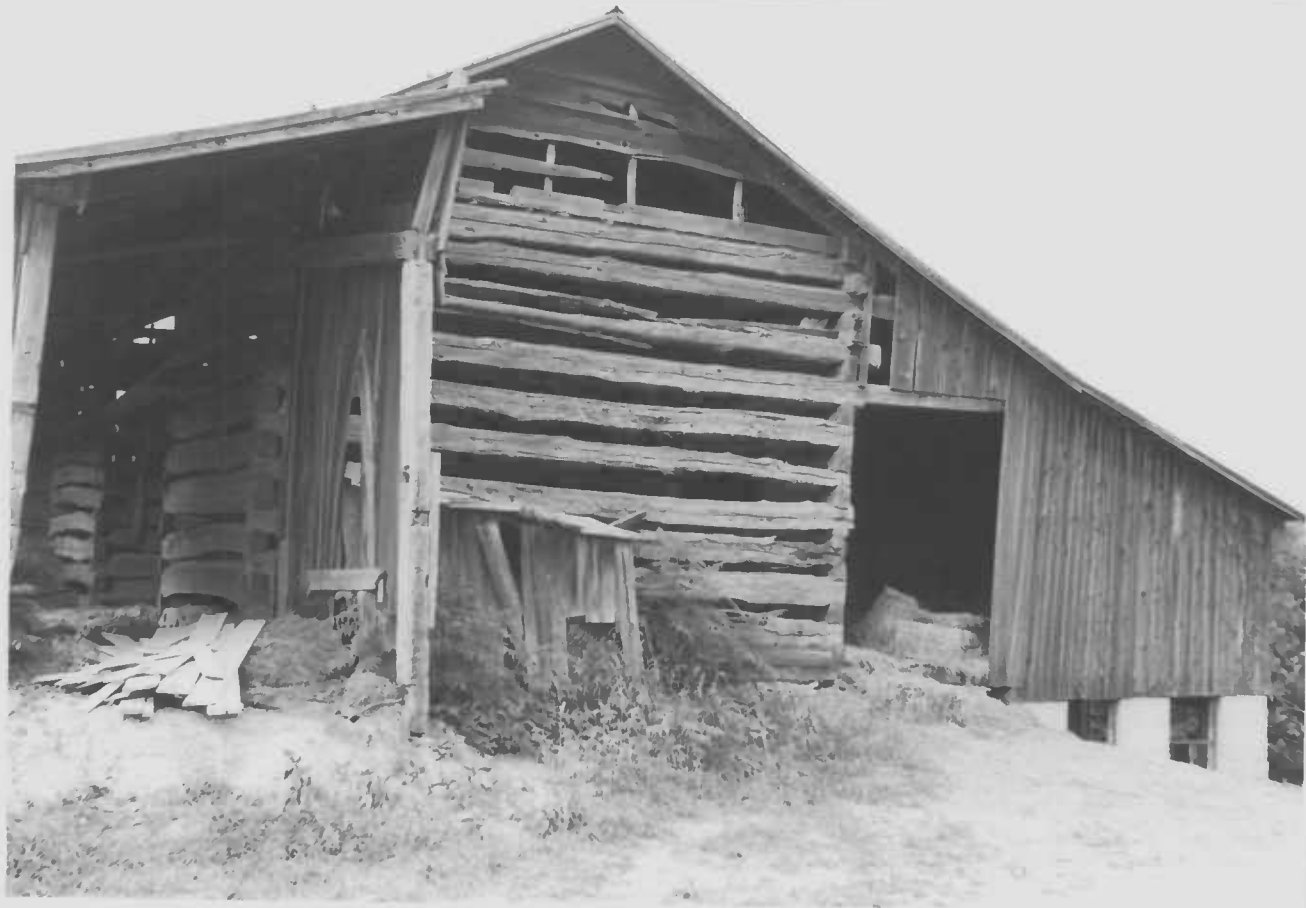
Cabin Run Road Log Barn

Northwest elev.

The log barn is covered by a gable roof running north-south. The 50' x 20' structure includes two 15' x 20' log pens with a central aisle.

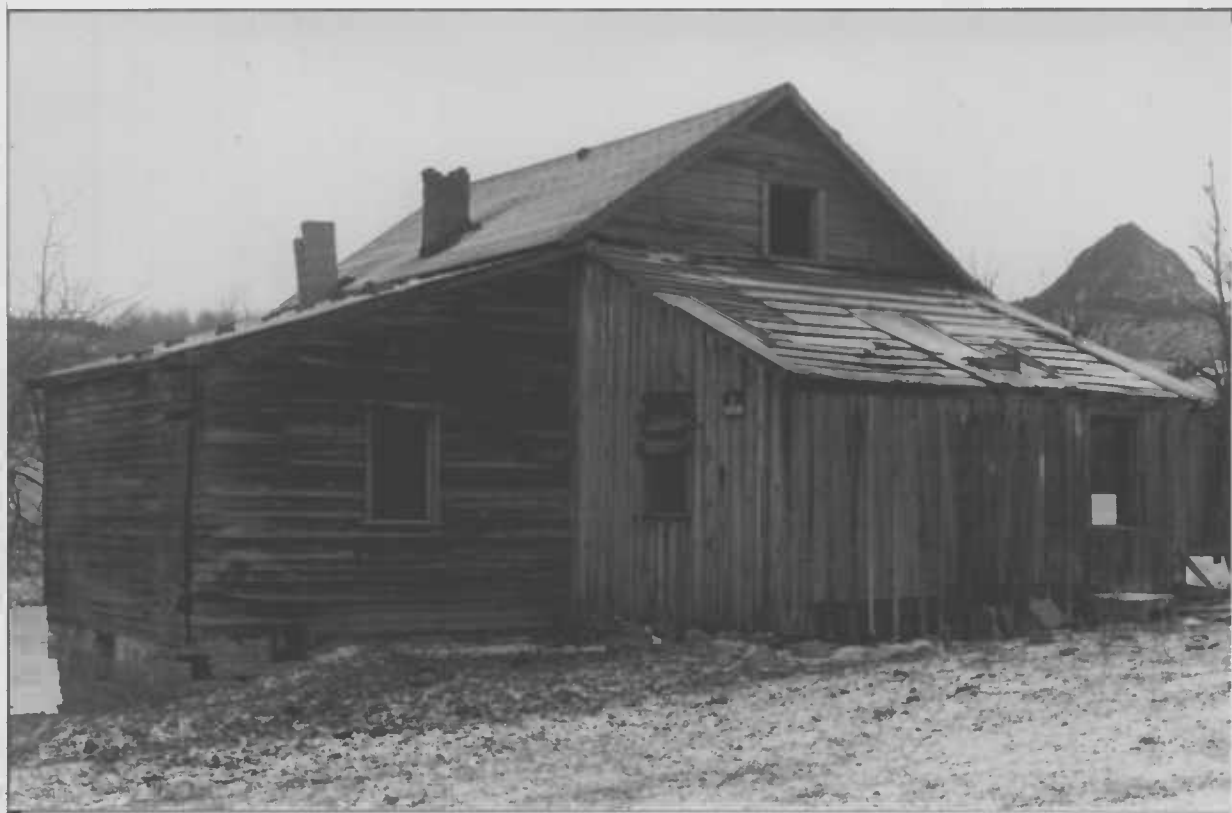
Log Farm House

South ~~east~~

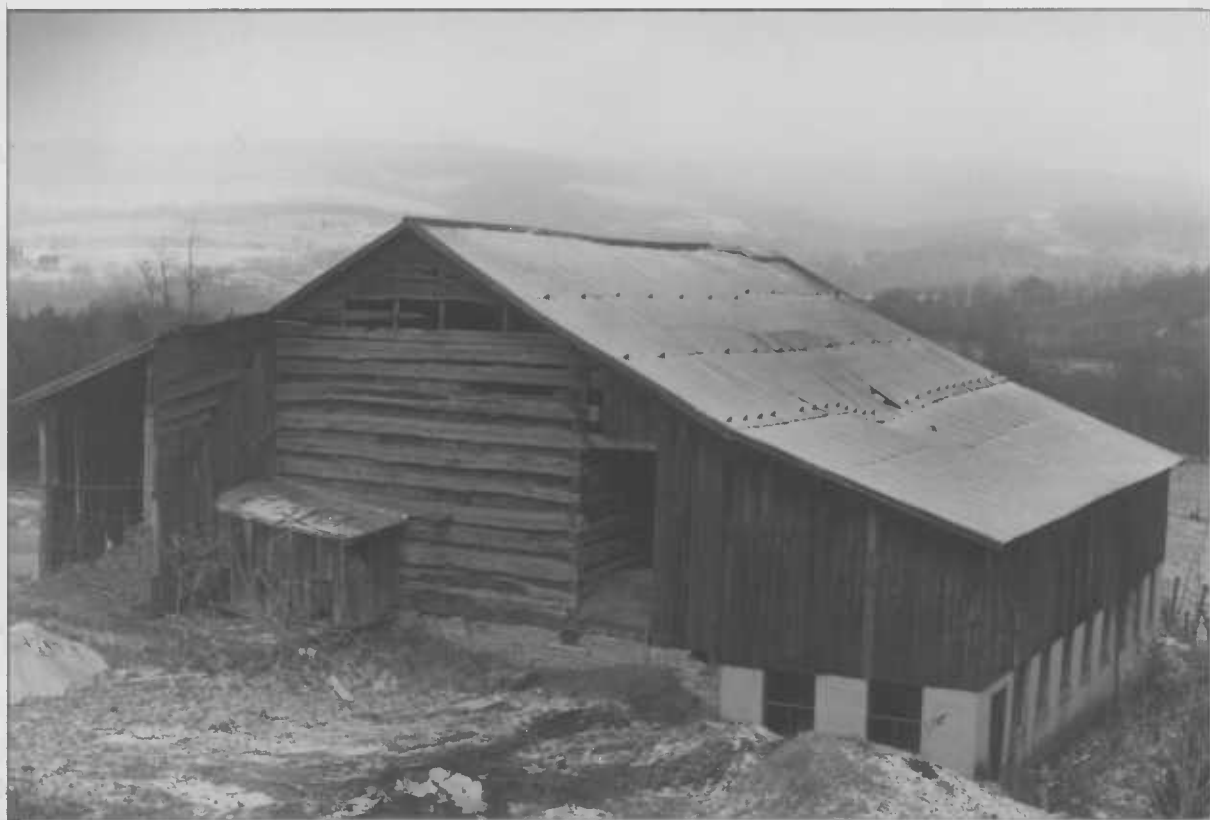
Log Farm Barn

Northwest
